M E M O R A N D U M October 2, 2013

SUBJECT: Public hearing and consideration of a demolition permit for the

building located at 3315 4th St., a non-landmarked building over 50 years old, pursuant to per Section 9-11-23 of the Boulder Revised

Code 1981 (HIS2013-00197).

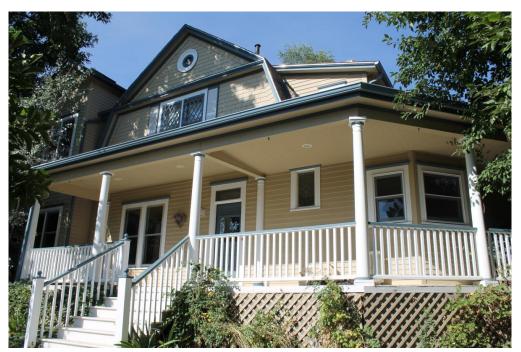
Figure 2. East Façade, 3315 4th St., 2013

The east façade features a pair of original double-hung windows on the first level, located to the south of the front door, which features a transom window. A stained glass window, not original to the house, is located to the north of the front door. Double-hung windows are also located on the northern bay end of the east façade. A pair of double-hung wooden windows is located on the second level, and features a wooden lattice window screen that mimics typical glass patterns common to this building style. A round window is located at the peak of the gambrel roof form. The original wood shingles are located on the gable end and are painted. A wrap-around porch with classical columns and a simple wooden railing is located on the north and east sides of the first level. A vertical, two-story addition is located at the south end of the east façade and features pairs of double-hung windows on the first and second levels. A shed roof addition extends from the north slope of the roof. *See Attachment A: Current Photos.*

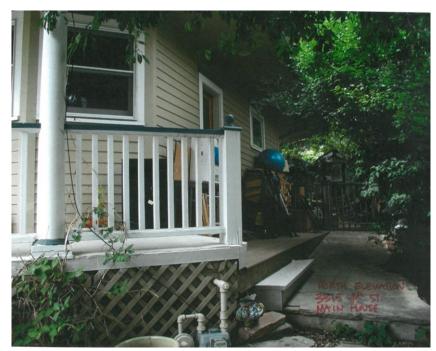
Figure 3. North Elevation, 3315 4th St., 2013

The 1998 addition obscures the historic portion of the north, west and south elevations. The north elevation features a bay at the northeast corner of the house, and newer casement windows and doors.

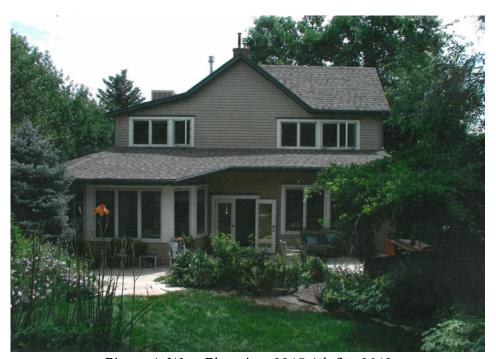
Figure 4. West Elevation, 3315 4th St., 2013

The west elevation features a complex roof form, with a gable at the center, a shed roof at the north, and a large gable facing south. A polygonal bay is located at the north end of the west façade. Large casement windows and doors are located at the rear. A shed roof overhang delineates the first and second floors.

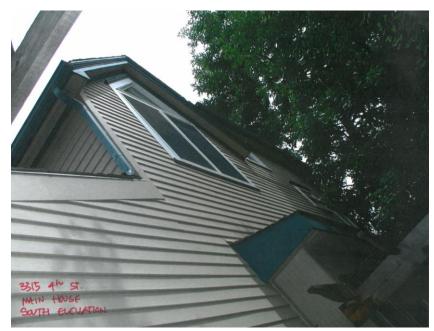
Figure 5. South Elevation, 3315 4th St., 2013

The south elevation features a gable roof end with a pair of casement windows with a triangular window above, and a shed roof portion with two windows at the east end of the south elevation.

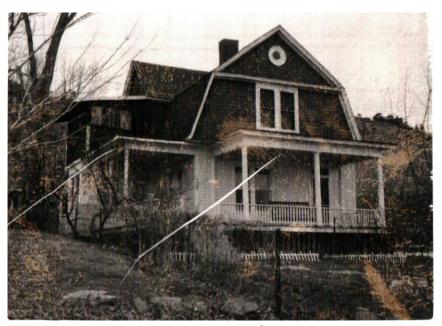
Figure 6. Tax Assessor Photo, c. 1961.

The original, vertically-proportioned form of the house is evident in the c. 1961 tax assessor photograph. The house featured a flat-roof porch with three classical columns and a simple railing. A second porch was located at the south elevation; the date of its construction is unknown. The gable and shed roof portions of the house visible in the tax assessor photograph are thought to have been early additions to the house, though the date of that alteration is unknown.

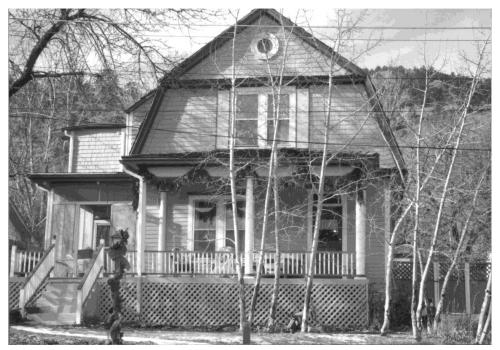
Figure 7. 3315 4th St., Architectural Survey Photograph, 1995.

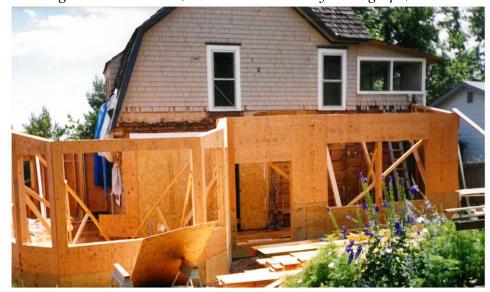
The house was significantly altered in 1998 by the construction of an addition that wrapped around the south, west and north elevations.

Figure 8. View of addition at north elevation under construction, 1998.

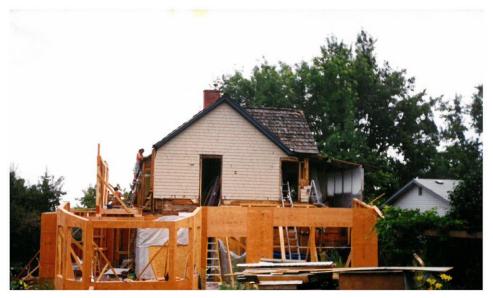
Figure 8. View of addition at west (rear) elevation under construction, 1998.

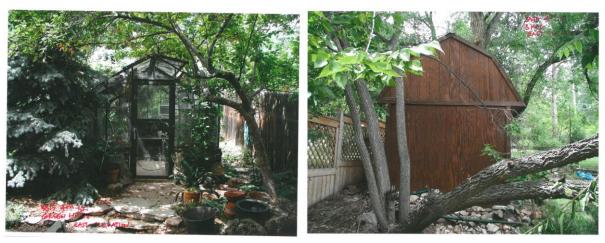
The lot features mature landscaping, with a thriving floral garden at the front and a koi pond, mature trees and plans at the rear. The applicant is also proposing to demolish two non-historic accessory buildings on the lot.

Figure 9. View of two non-historic accessory buildings proposed for demolition, 1998.

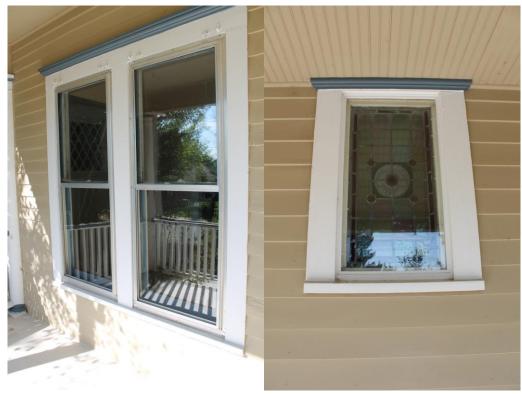
3155 4th St., View of windows on east façade, 2013.

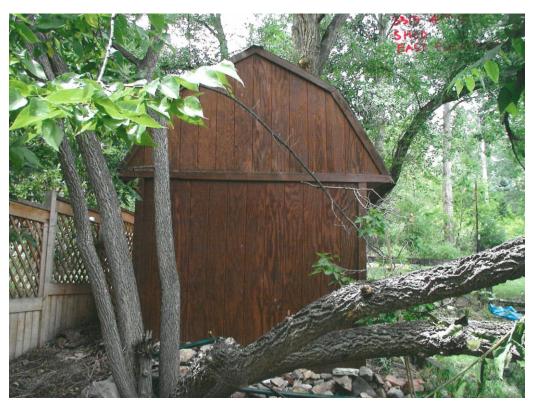
$3155 \ 4^{th} \ St.$, View of shed proposed for demolition, 2013.

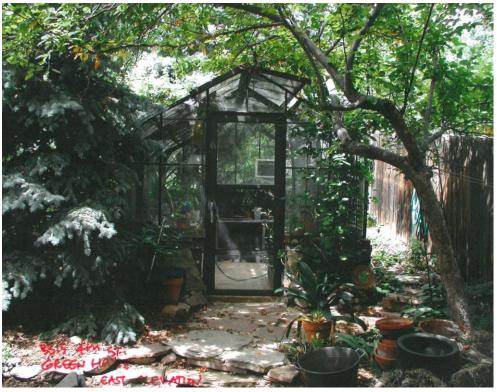
3155 4th St., View of greenhouse proposed for demolition, 2013.
